Test Report

Contract No : 16092106B
Issue Date : Sep. 30, 2016
Applicant : GOOD FOCUS CORP.
Address : No.293, Sec.1, Fuxing E. Rd. Chubei City, Hsinchu County, Taiwan
Product : Brake pad (Mountain)
Model No : GF-Q108A-1
Test Standard : As shown in the test report

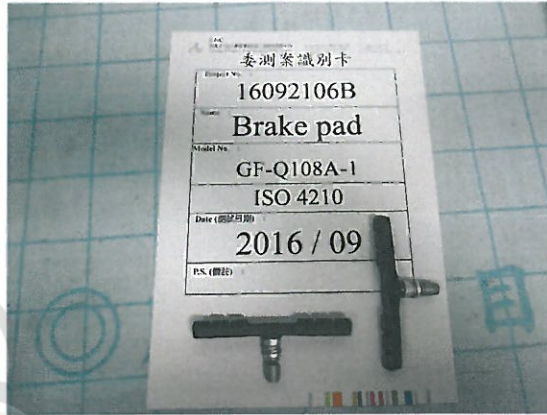
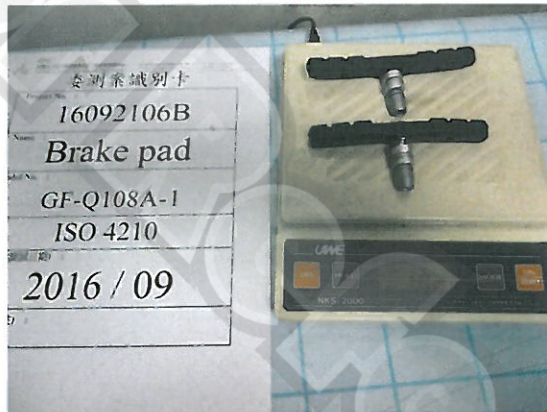
Fig. 1 Test sample

The sample is shown in Fig. 1. Specification of the sample is shown in Tab. 1 .

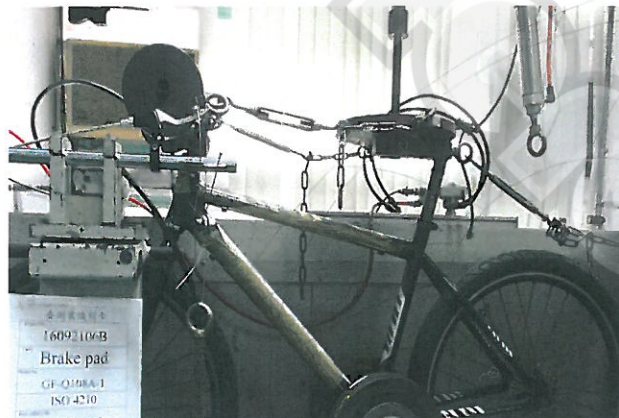
Fig 2 Braking performance test

Braking operate-force ($F_{Op} / F_{Op\ intend}$)		40	60	80	100	120	140	160	180
Front	$F_{Br\ average}^D$	184	283	369	438	532	---	---	---
	$F_{Br\ average}^W$	143	193	232	293	316	---	---	---
	$F_{Br\ average}^W : F_{Br\ average}^D$	0.77	0.68	0.63	0.67	0.59	---	---	---

No.	Test item		Requirement:	Condition	Result
1	Braking performance (Machine test method)	Dry condition	Front : ≥ 425 N	12.5 km/hr, Load: 100 kg	Pass, Fig. 2, Tab. 5
		Wet condition	Front : ≥ 220 N		Pass, Fig. 2, Tab. 5
		Linearity	Between $\pm 20\%$		Pass, Fig. 3
		Ratio between wet and dry	> 0.4		Pass, Tab. 5
2	Brakes- Heat-resistance test		$\geq 60\%$	75 Wh	Pass, Tab. 6 Fig. 4

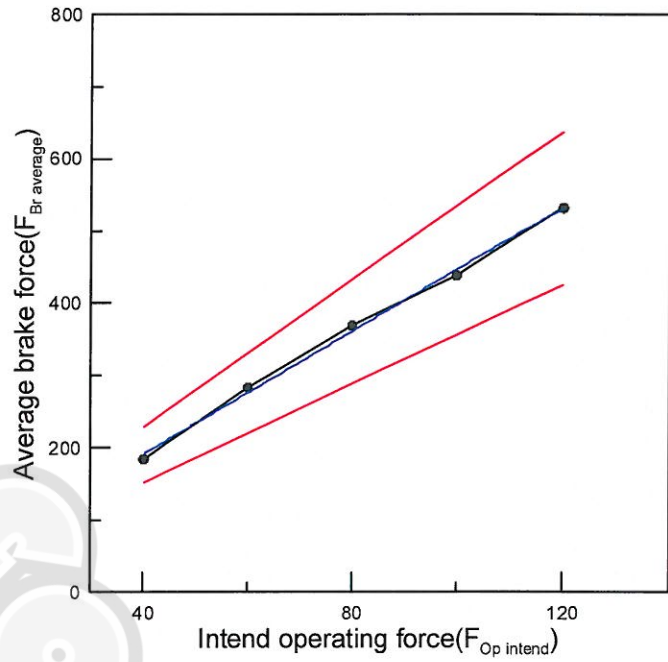
3(a) Front brake - Dry condition

Fig 3 Braking performance - Linearity curve

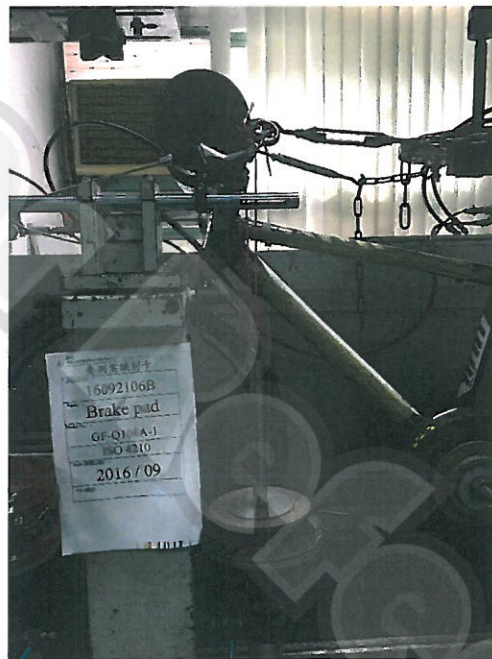
Fig. 4 Brakes - Heat resistance test

Brake condition		Before	After	Ratio	Requirement
Front	$F_{Br\ average}^D$ ($F_{op} : 120\ N$)	532	556	104 %	>60 %
	$F_{Br\ average}^W$ ($F_{op} : 120\ N$)	316	338	107 %

The 43 mm gap between the hand-brake lever and the handlebar-grip after the test.

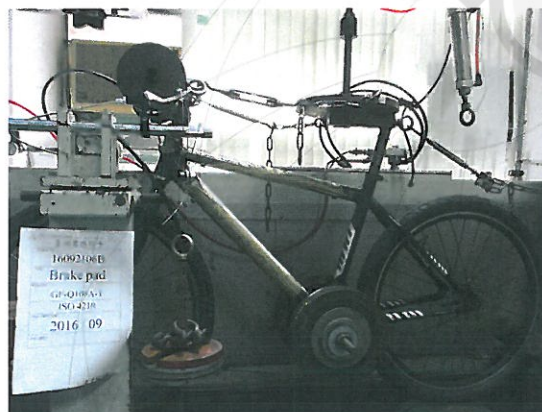
Fig. 5 Mechanical endurance test

No.	Test item	Requirement	Condition	Result
3	Mechanical endurance test	There shall be any fractures or visible cracks in the any part of brake system.	1. V: 12.5 km/hr \pm 5 %. 2. Loading: 100 kg. 3. Braking 3 sec and release 3 sec for 3,000 cycles. 4. Deceleration efficiency could not over 2.20 m/s ² \pm 10 %.	Pass Fig. 5
